## The Rediscovery of a Labour Camp on the Construction Site of the Stalin Monument in Prague

**Abstract:** The rediscovery of a labour camp on the construction site of the Stalin Monument in Prague in spring 2021 was the result of a construction project of the Municipality of Prague. Until then, the existence of this specific site had not been reflected neither in the historical memory of the place nor in the literature devoted to the monstrous monument (dismantled in 1962), which was both a superb work of art and engineering and the most significant material manifestation of the cult of Stalin's personality

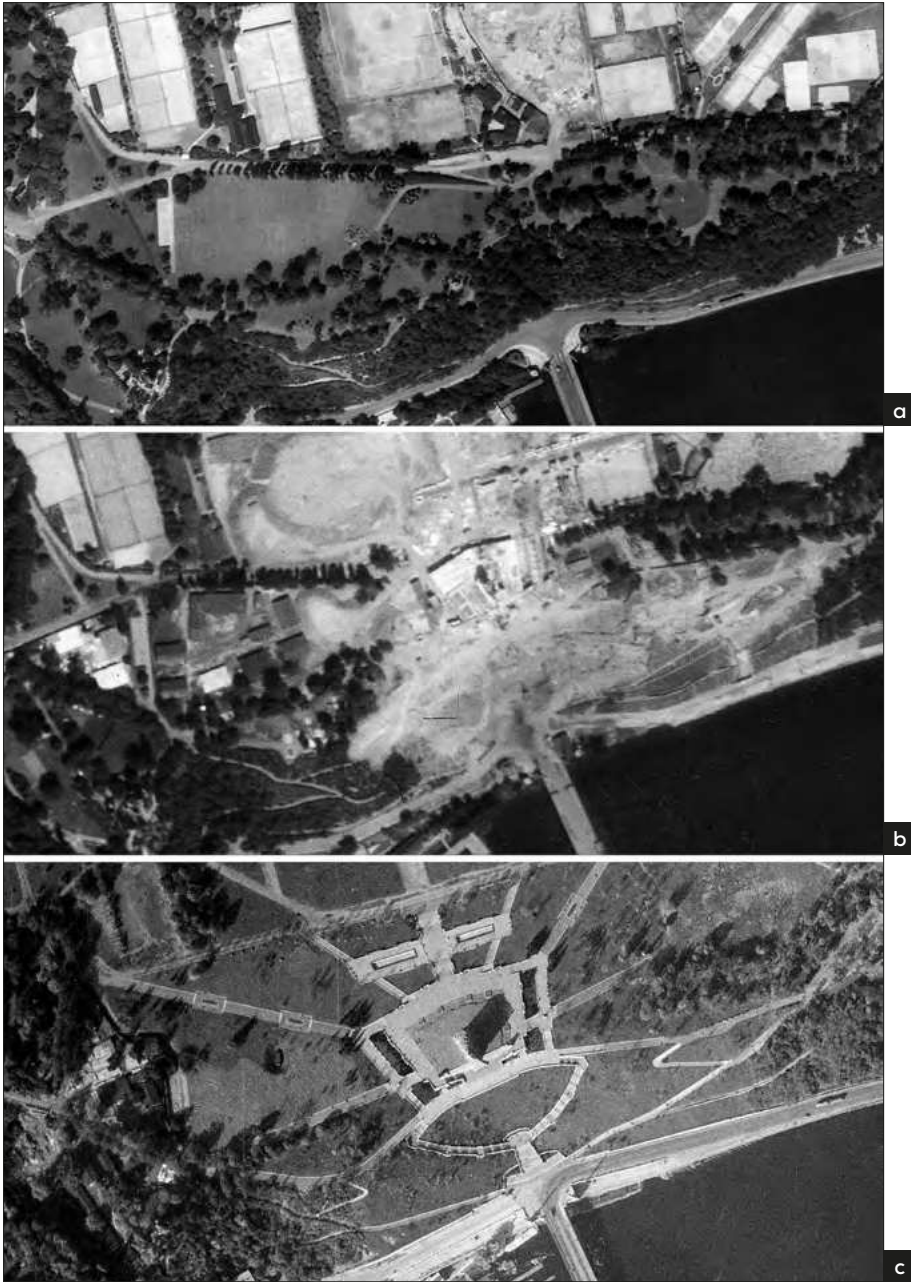
**Fig. 4.** Vertical photographs of the Letná area: (a) 1949; (b) 1953 (the red arrow marks the labor camp); (c) 1957 (source: The Military Geographical and Hydrometeorological Office of the Czech Republic).

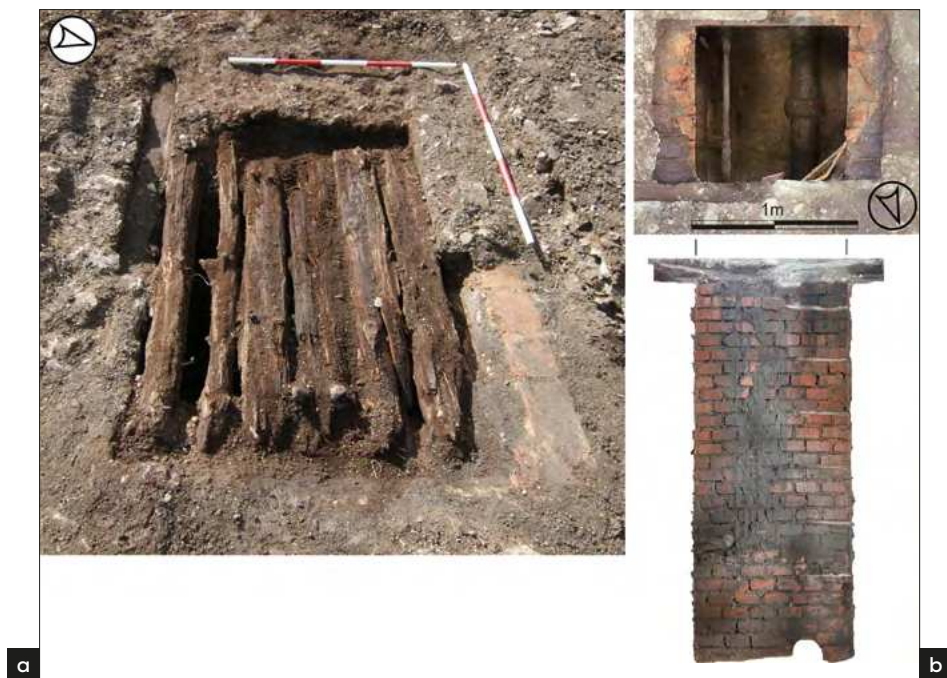
**Fig. 10.** Revision shaft at the camp sewerage close to the kitchen building: (a) temporary covering of the shaft with secondary used beams that were poured with a thin cement mixture, which is already removed on the field photograph (photograph by D. Pilař); (b) plan and southern profile of the shaft.

Regarding the infrastructure remains, it is necessary to mention the components of the overhead and underground power lines, but these were relocated during the demolition and its course cannot be reconstructed. On the other hand, the backbone of the sewerage system, visible in the GPR data, is well locatable, and was revealed in the field by a pair of inspection shafts (Fig. 10). In the case of the northern one, an improvised repair of the destroyed cast-iron capping (its remains were found at the bottom of the shaft) with a layer of secondarily used beams poured with thin concrete was demonstrated. The site also included a well in the north-west corner, which reaches a depth of 7 m. It can be connected to the camp due to the use of identical bricks as in the other buildings; unfortunately, the mechanism of pumping and possible water distribution has not survived. Available archaeological records also didn't allow us to answer the very important question regarding the fencing of the whole area.
